J. ARONSTEIN

HAZARDOUS FPE CIRCUIT BREAKERS AND PANELS

Information for Homeowners, Inspectors, and Electricians

*(Updated December 2, 2011)**

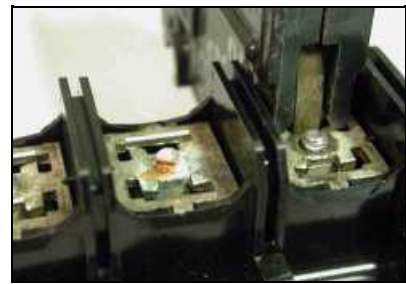
C. Stab socket on a post, attached with an 8-32 steel screw.

Of the three types illustrated, the one shown in Figure 2-C is known to have a high probability of deteriorating and overheating of the stab socket structures when subjected to significant current flow. Each individual stab socket plate is connected to its bussbar via a post (spacer), and the assembly is held together by an 8-32 steel screw. FPE panels with this construction are prone to overheating failure. Eight of the panels of the present study that showed evidence of serious overheating were constructed this way. One example is shown in Figure 3.

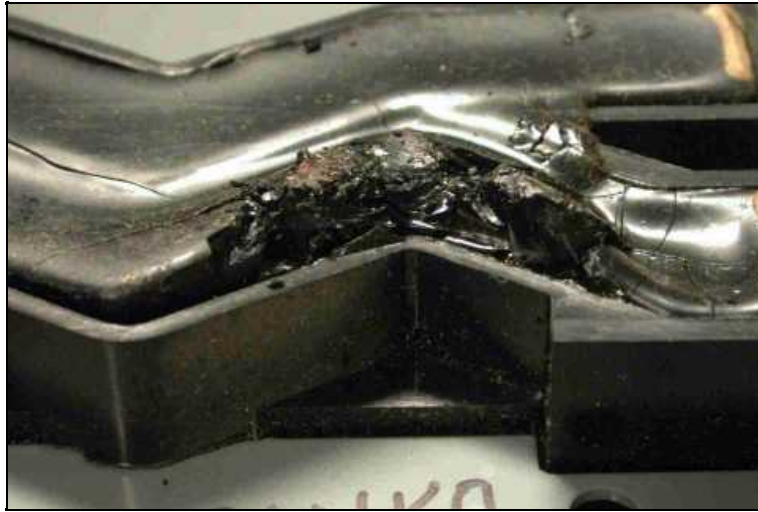
FIGURE 3 - OVERHEATING AT THE CONTACT BETWEEN THE BUSSBAR AND THE STAB SOCKET ASSEMBLY CAUSED THIS DAMAGE TO THE INSULATION.

(This view is of the backside of the panel. The damage cannot be seen unless the panel is taken out of the enclosure.)

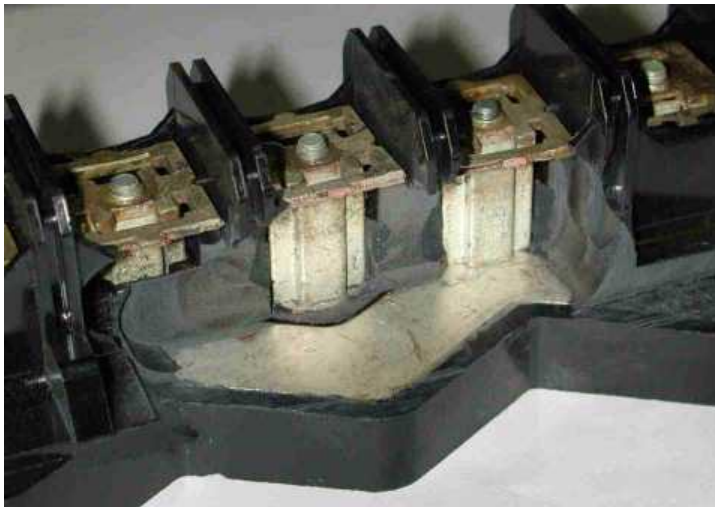
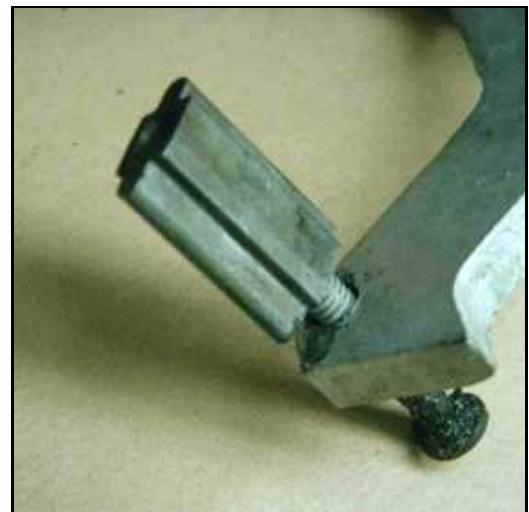
FIGURE 4 - CONDUCTING PATH FROM BUSSBAR TO STAB SOCKET

A more serious failure of this type has been documented.¹ In that instance, the failure had been severe enough to ignite a smoldering fire on the plastic insulating material. The fundamental weakness in this design is the use of a single, relatively flimsy 8-32 screw to hold a structure together that can feed up to four half-width breakers with a total "ampacity" (rated circuit capacity) up to about 160 Amps. Figure 4 shows how the stab socket plate and post are attached to the busbar.

Various material combinations were utilized by FPE in these assemblies. Some bussbars are copper, others are aluminum. Some posts are copper, others are aluminum. The worst case (most likely to fail) is where both the bussbar and the post are made of aluminum, and the best case (least likely to fail) is where both are made of copper. Inspectors (or homeowners, or electricians) have no way of knowing which materials are utilized in any particular FPE panel with this type of construction.

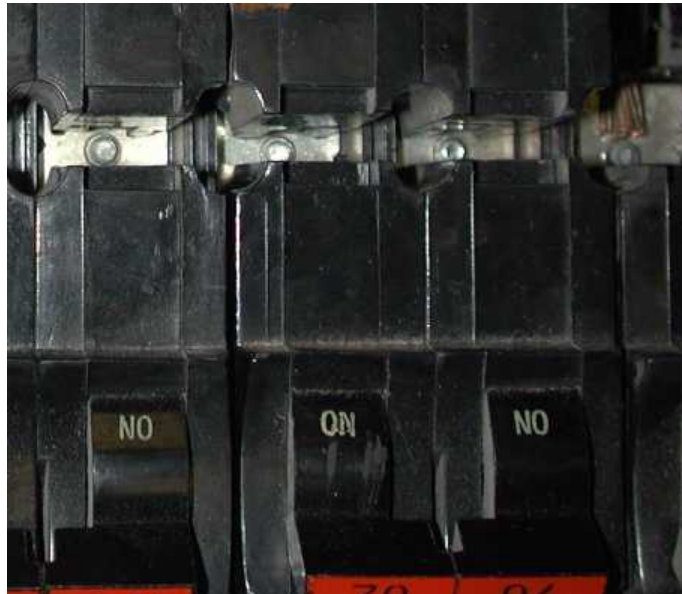
Inspectors can, however, determine if a particular FPE panel has this type of construction, and, to a limited extent, whether it has failing bussbar interconnections that have previously overheated. With the panel cover off, for this type of panel, the inspector can see the ends of the screws that attach the stab socket plates, as shown in Figure 5. (Note: If there are slotted screwheads visible, that is a different type of panel construction.) The stab socket plates and the visible ends of the screws should have a bright metallic look. Darkening, discoloration, or signs of corrosion most likely indicate past episodes of abnormal overheating.

FIGURE 5 - THE ENDS OF THE SCREWS HOLDING THE STAB SOCKET PLATES ARE VISIBLE BETWEEN THE TWO ROWS OF BREAKERS. THIS IDENTIFIES IT AS A PANEL OF THE TYPE SHOWN IN FIGURE 2-C

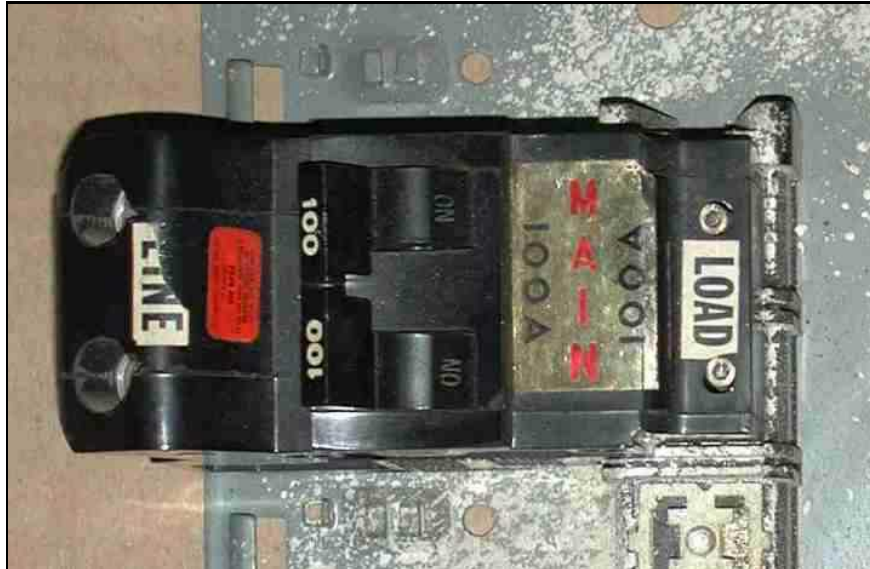
Some FPE Stab-Lok[®] panels have 100-amp main breakers that feed into the bussbars through the same plate and post system. In this design, the two main breaker output terminals do not have the stab type contact. Instead, each one is screwed down to a plate the same size as the stab socket plate, but which has a threaded hole in it instead of the stab openings. As with the plate and post assembly, the screws clamping the main breaker to the busbar assembly are size 8-32, which is absurdly small for a 100-amp main breaker connection, and this is another common point of overheating failure.

FIGURE 6 - FPE 100-AMP MAIN BREAKER CONNECTS TO THE BUSBARS THROUGH THE PLATE & POST CONFIGURATION, USING ONE SOCKET-HEAD 8-32 SCREW FOR EACH POLE TO ATTACH TO ITS CONTACT PLATE.

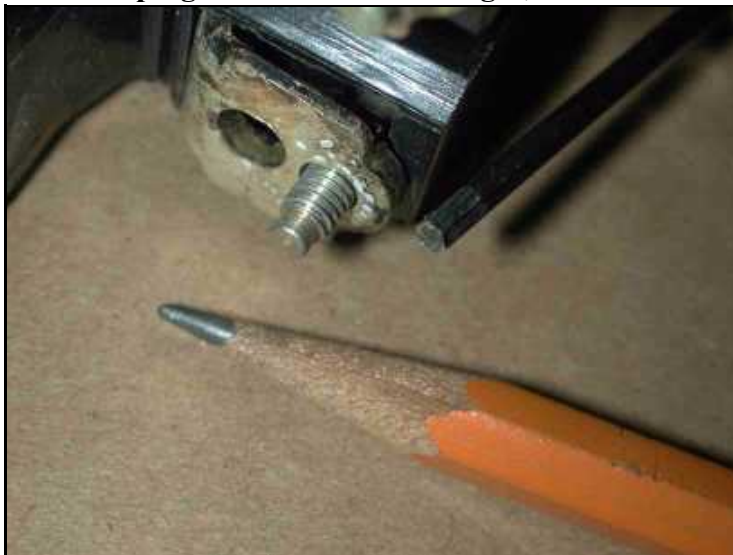
To put the diameter of the 8-32 screw in perspective, it is the same size as used on common receptacles for connecting #14 or #12 copper wire (for 15- and 20-amp circuits), with a diameter of only about 5/32". An FPE panel and main breaker of this type is shown in Figure 6. The main breaker's output terminal mounting screws and the tiny Allen-wrench that fits them are shown in Figure 7.

FIGURE 7 - ONE LOAD-SIDE CONTACT AND ITS 8-32 CLAMPING SCREW, ON THE FPE 100-AMP MAIN BREAKER OF FIG. 6. THE SCREW-HEAD TAKES A 3/32" ALLEN WRENCH, WHICH IS ONLY SLIGHTLY LARGER THAN THE LEAD OF THE PENCIL.

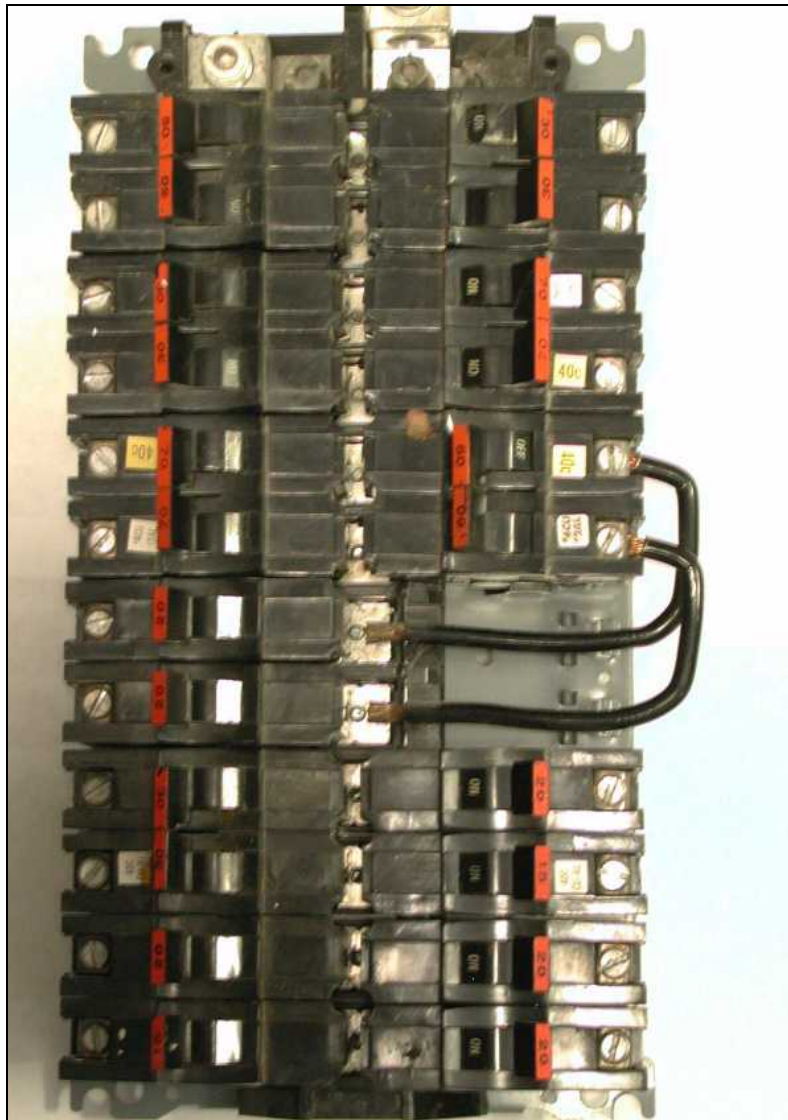
FIGURE 8 - FPE STAB-LOK® "RULE-OF-SIX" (SPLIT-BUS) PANEL WITH NO MAIN BREAKER. THE JUMPER CABLES ON THE RIGHT SIDE FEED THE LOWER SECTION.

There are many different design variations, but the essential element is that in these "rule of six" panels there is no main breaker, and, typically, the lower section of the panel is fed from jumpers coming from the output of one of up to six double-pole breakers in the upper section. The FPE Stab-Lok® double pole breakers have a relatively high probability of jamming when called on to trip, however, as previously demonstrated by the test results presented in Section 2. That means that the home with an FPE "rule-of-six" panel has an unacceptably high probability of having one or more circuits that are totally unprotected, in which the maximum current flow is only limited by what the transformer on the pole can deliver. That may be of the order of 1,000 Amps or more.

On first glance, the FPE Stab-Lok® panel previously shown in Figure 8 looks normal. In fact, however, it clearly demonstrates several of the hazardous failure modes discussed in the previous sections. It is one of those collected for the recent testing. It is from a home built in 1974, whose new owners had determined in 1999 that it should be replaced. Their decision to replace it was in part prompted by information available on the internet regarding FPE breaker problems.⁷ According to the homeowner, who sent it to me for examination and testing, *"We recently had it replaced and found the breaker to the dryer fried in just the way described. Our electrician was astonished. Two others we had bids from dismissed our concerns with contempt."*⁸

There are additional problems in this panel. Overheating damage occurred to the insulation on the backside of the panel. Further, in addition to the dryer breaker that failed (jammed) in the home, two other two-pole breakers from this same panel failed in the lab testing. All this in a panel that looked OK from the front!

Everything in the home was functioning. The dryer worked. Why wouldn't it, since the circuit breaker was jammed with its contacts closed? Keep in mind that this panel is one of the "rule-of-six" configuration. Before they replaced this panel, the homeowners unknowingly had a situation where, essentially, the clothes dryer was wired straight through to the power line transformer on the pole, with no functional circuit protection at all.

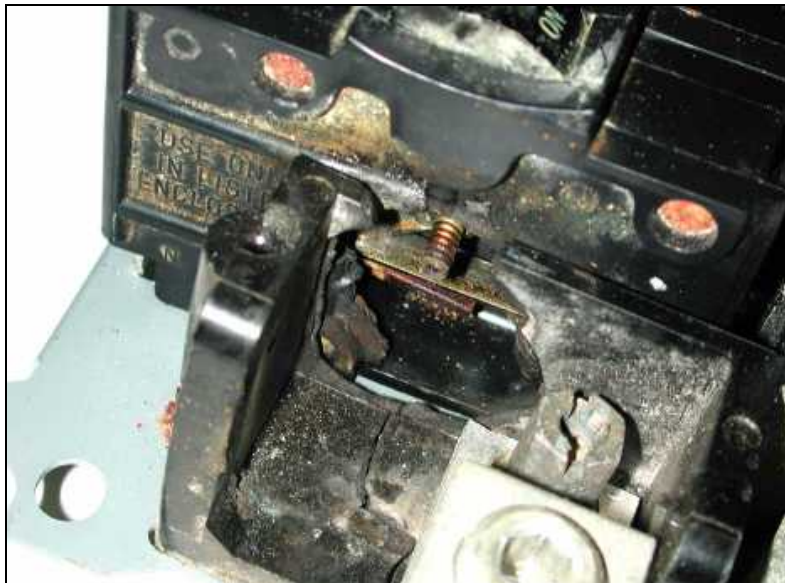
Viewing the panel from the front, some signs of overheating (as previously discussed) are evident. These are subtle compared to the view looking down at the top right (dryer) breaker, as in Figure 9.

The main service cable connector has been rotated out of the way for better visibility of the damage. The plastic insulator is burnt and cracked. The breaker's internal mechanism can be seen through the hole burned through its side. Figures 10 and 11 show the damage to the separate items.

FIGURE 9 - VIEW DOWN TOWARD UPPER RIGHT OF PANEL SHOWN IN FIG. 8. THE FPE STAB-LOK® TWO-POLE 30-AMP BREAKER FED THE CLOTHES DRYER.

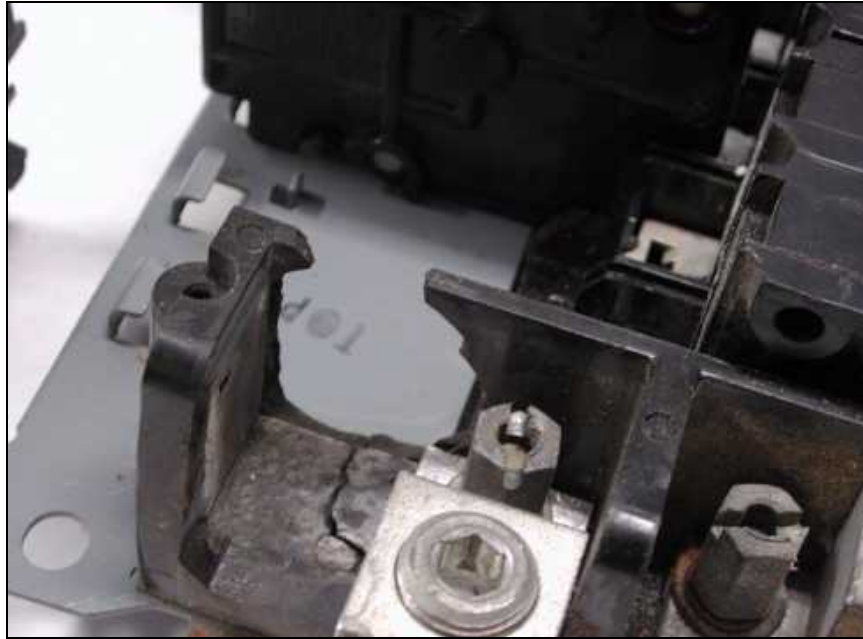
FIGURE 10 - THE DAMAGE TO THE INSULATING STRUCTURE OF THE PANEL (FIG. 8) IS MORE CLEARLY VISIBLE WITH THE BREAKER REMOVED.

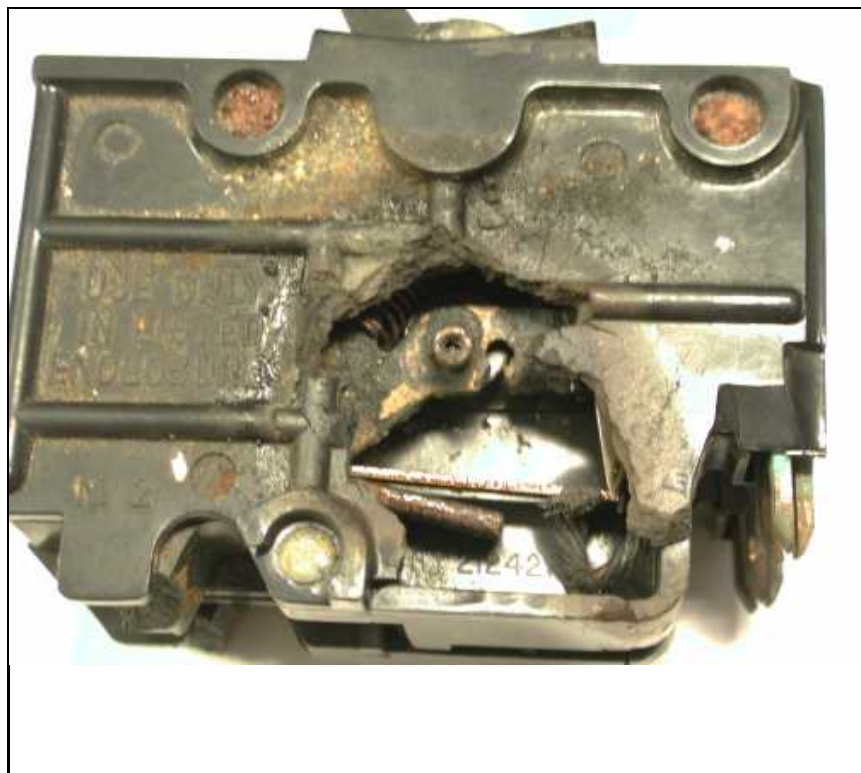
FIGURE 11 - THE FAILED FPE STAB-LOK® DRYER BREAKER (UPPER RIGHT, FIG. 8)

The damage to the breaker, from some previous high current event, is exactly as had been demonstrated in the tests done for CPSC.^{2,3,4} Those tests demonstrated that, when an FPE breaker jammed and the current exceeded about 300% of the breaker's rating, the side of the breaker disintegrated and/or ignited from the heat being generated within the breaker. This is due to resistive heating of the breaker's internal current-carrying components, mainly the bimetal element and the flexible copper braid that connects to it. This is not an arcing failure, although the damage to the insulating materials of the breaker and panel sets the stage for an arcing fault to occur.
