J. ARONSTEIN

HAZARDOUS FPE CIRCUIT BREAKERS AND PANELS

Information for Homeowners, Inspectors, and Electricians

*(Updated December 2, 2011)**

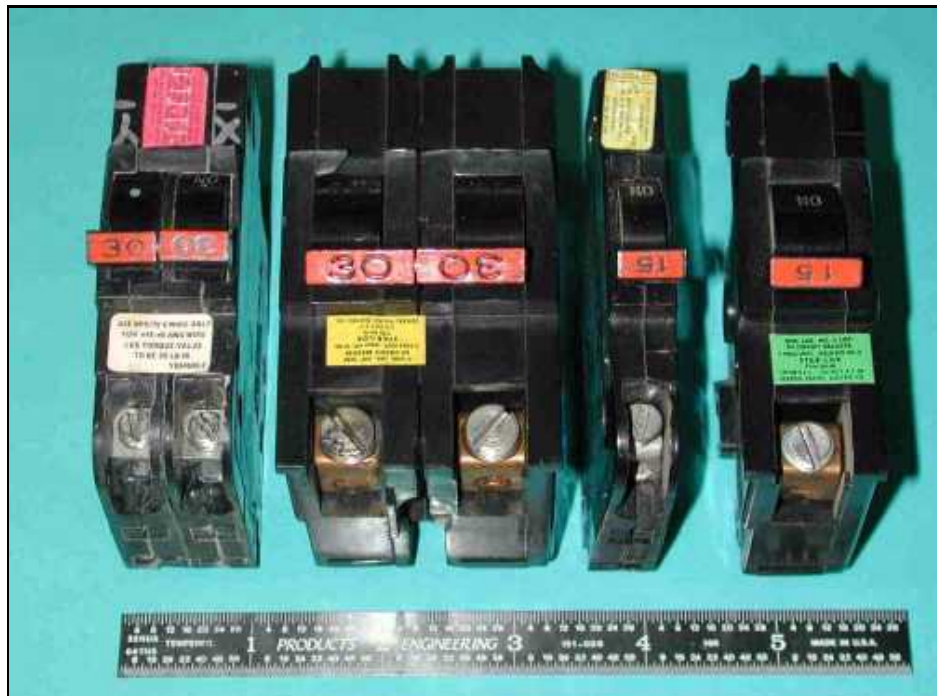
FIGURE 1 - REPRESENTATIVE SAMPLES OF HALF- AND FULL-WIDTH FPE STAB-LOK[®] CIRCUIT BREAKERS (left to right: 1/2-width double pole, full-width double pole, 1/2-width single-pole, full width single-pole)

Note that the color and style of the handle varied over the years, and that some FPE Stab-Lok[®] breakers (type NB) have screw connection to the bussbar instead of the "Stab-Lok" feature.

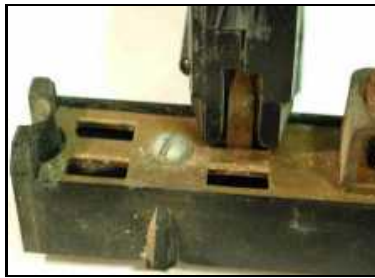
Even if it were possible to replace all of the suspect FPE Stab-Lok® breakers with a more trustworthy type, that would not correct hazardous internal failure modes intrinsic to many of the FPE panels. Nine of the FPE Stab-Lok® panels in the present study showed evidence of internal overheating due to this type of failure. The overheating ranged from mild to severe in these failing panels.

The "panel" is the unit within the enclosure, on which the breakers are mounted. The main electrical service feeders (electrically live, from the meter) are connected at the panel, and the panel has an internal conductor system that distributes the power to the individual circuit breakers. The internal conductor system consists essentially of "bussbars" (thick metal bars) that have sockets incorporated or attached, into which the breakers' "stab" contacts are inserted. There are many different types of bussbar constructions in FPE panels, three of which are shown in Figure 2.

A. Copper buss bar with punched openings.

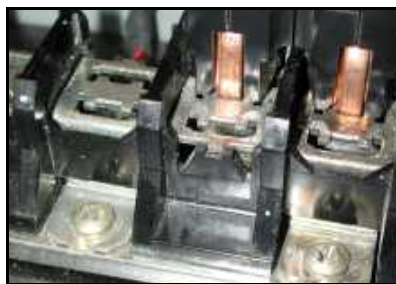
B. "Z" clip, clamped to bussbar with 10-32 screw.

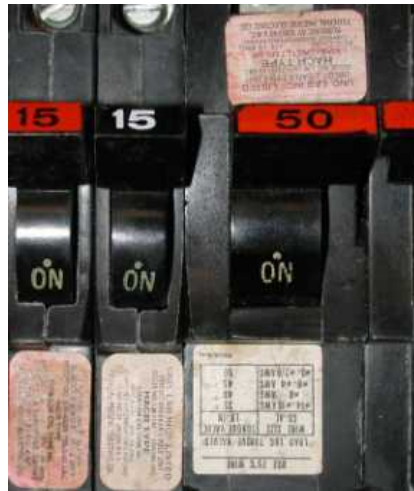
The question often arises as to whether there are any years or models of FPE Stab-Lok[®] circuit breakers that meet the standard performance requirements. The answer is that only FPE Stab-Lok[®] breakers with (authentic) pink UL listing labels *and* white dots on the handles are likely to perform as required by the UL standard. These breakers were manufactured after production restarted in about 1981, subsequent to the discovery and elimination of the company's fraudulent testing.¹⁴ The fraudulent testing practices existed prior to that -- from the time that the manufacturing operations were moved from Newark, NJ in the 1960s. The pink labels and white dots can be seen on the FPE Stab-Lok[®] breakers shown below in Figure 12. Inspectors are cautioned to check for both label color and white dot before concluding that the breakers were produced to UL requirements.

FIGURE 12 - FPE STAB-LOK[®] BREAKERS WITH WHITE DOT ON TOGGLE (ABOVE “ON”) AND PINK LABEL
